Report on the investigation of  
the loss of the yacht  
***Cheeki Rafiki***  
and its four crew  
in the Atlantic Ocean,  
approximately 720 miles east-south-east of  
Nova Scotia, Canada  
on 16 May 2014

## SYNOPSIS

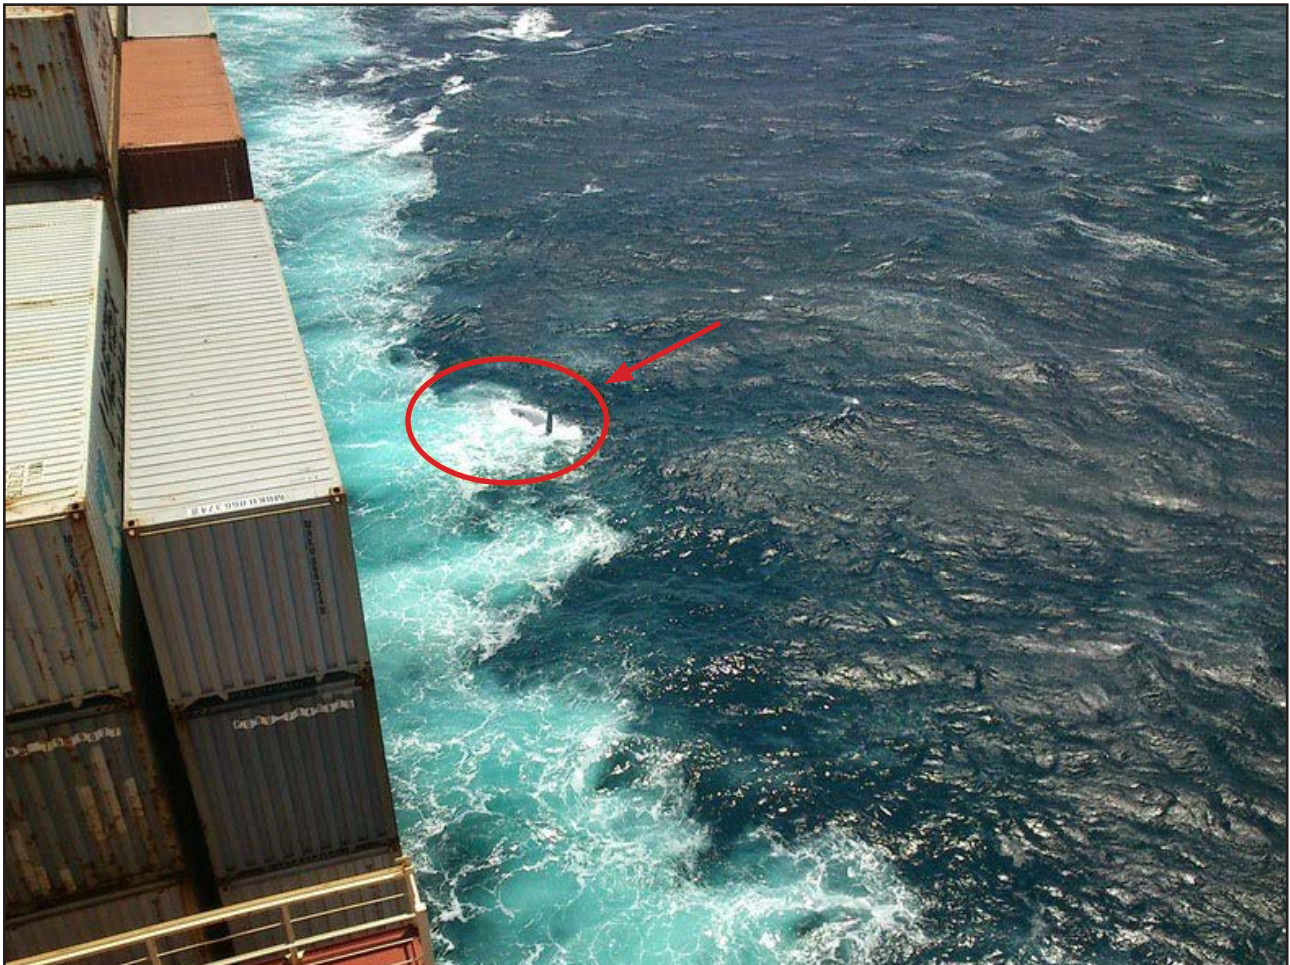
At about 1400 on 17 May 2014, the container ship *Maersk Kure* located the upturned hull of a small boat, which was believed to be *Cheeki Rafiki*. Adverse weather conditions prevented launching the ship's lifeboat or rescue boat (**Figure 6**) to carry out a closer inspection.

**Figure 6:** Photograph showing the upturned hull of a small boat alongside the container vessel *Maersk Kure* taken on 17 May 2014 at about 1400

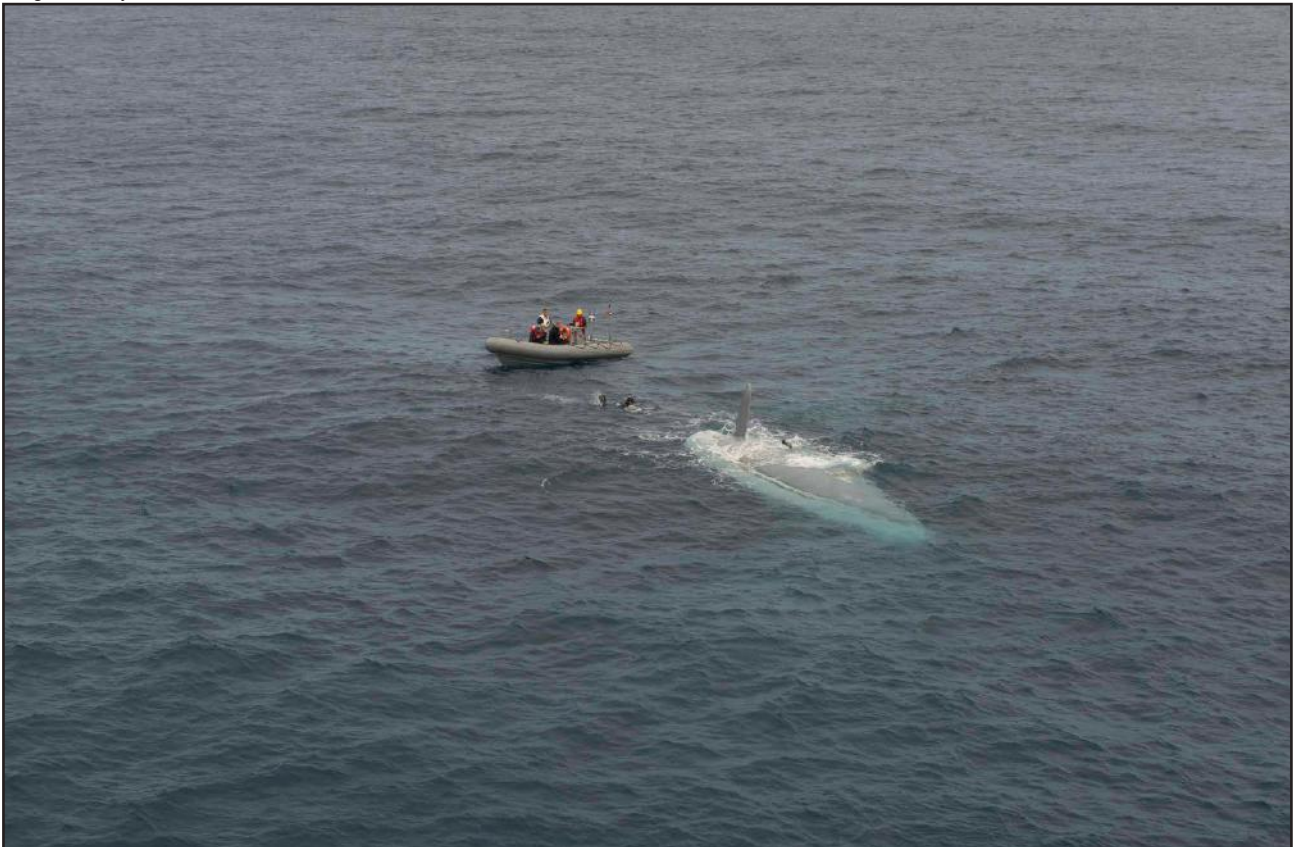
**Figure 7:** Photograph of Cheeki Rafiki's upturned hull being inspected by the US Navy

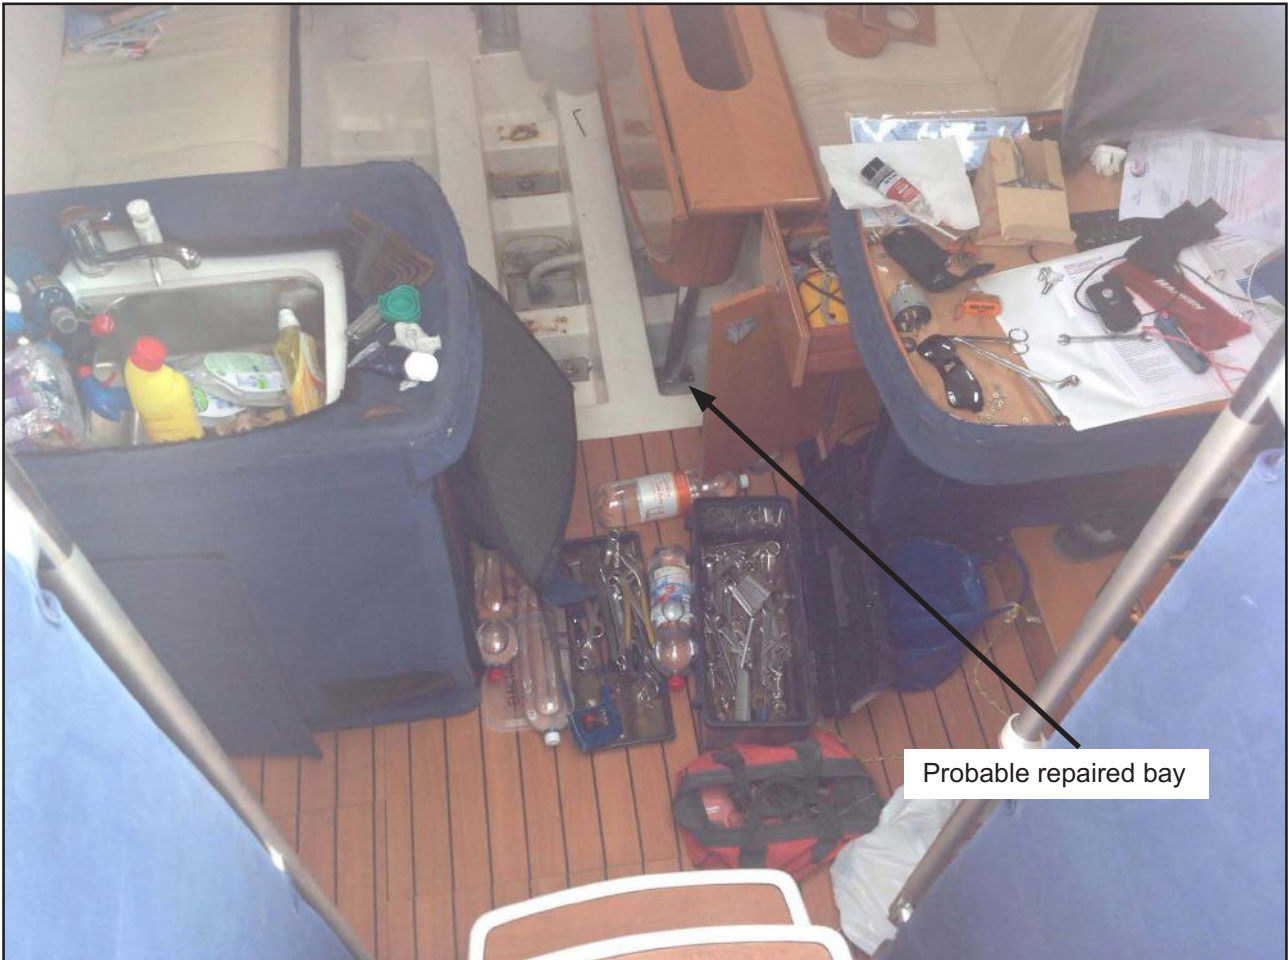
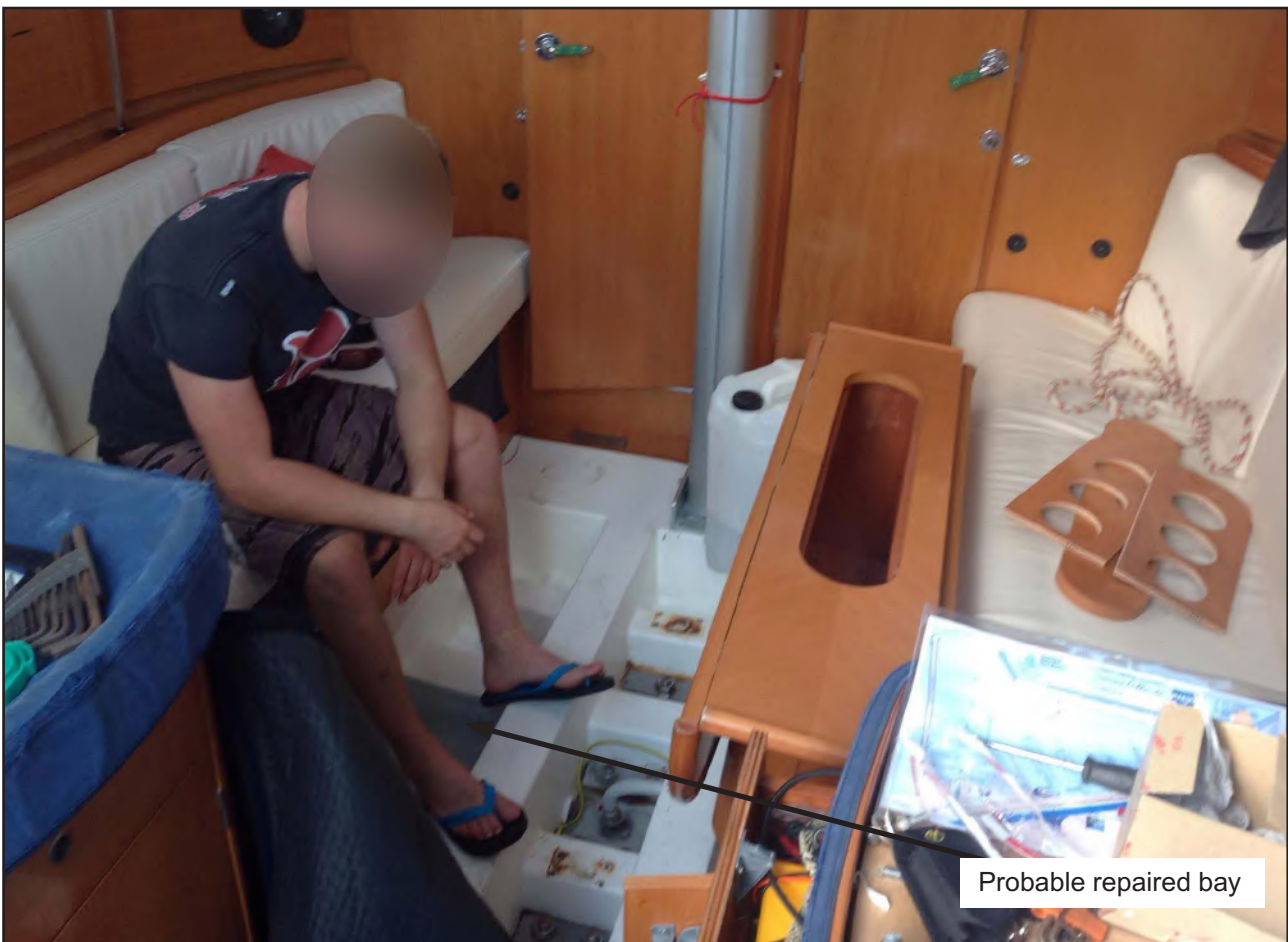
All of the repairers visited by MAIB inspectors agreed with Beneteau's advice to its after sales and dealer network that the keel should be removed when necessary. However, there is currently no industry-wide guidance on the circumstances that would necessitate keel removal.

The repair invoice also indicates that the repair was not carried out in accordance with Beneteau's recommended method contained in the advice to its after sales and dealer network. Of the repairers visited by MAIB inspectors, there was divided opinion as to the appropriate repair method and, again, there is currently no industry-wide guidance on this matter.

**Figure 16:** *Cheeki Rafiki's* keel bilge area prior to departure on the ARC 2013, with table temporarily removed

**Figure 17:** *Cheeki Rafiki's* keel bilge area prior to departure on the ARC 2013, with table temporarily removed

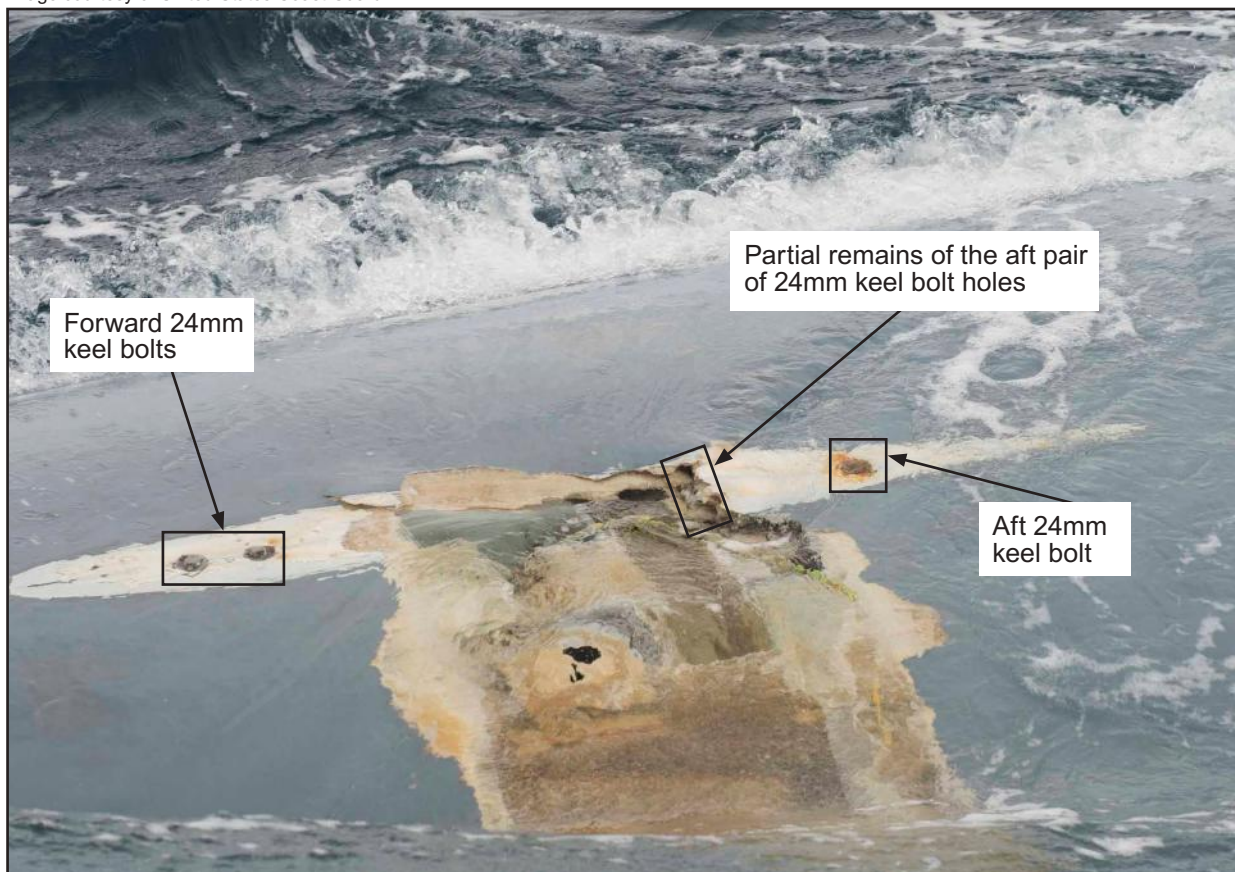
**Figure 18:** Photograph of *Cheeki Rafiki*'s upturned hull taken by the crew of USS *Oscar Austin* in the afternoon of 23 May 2014

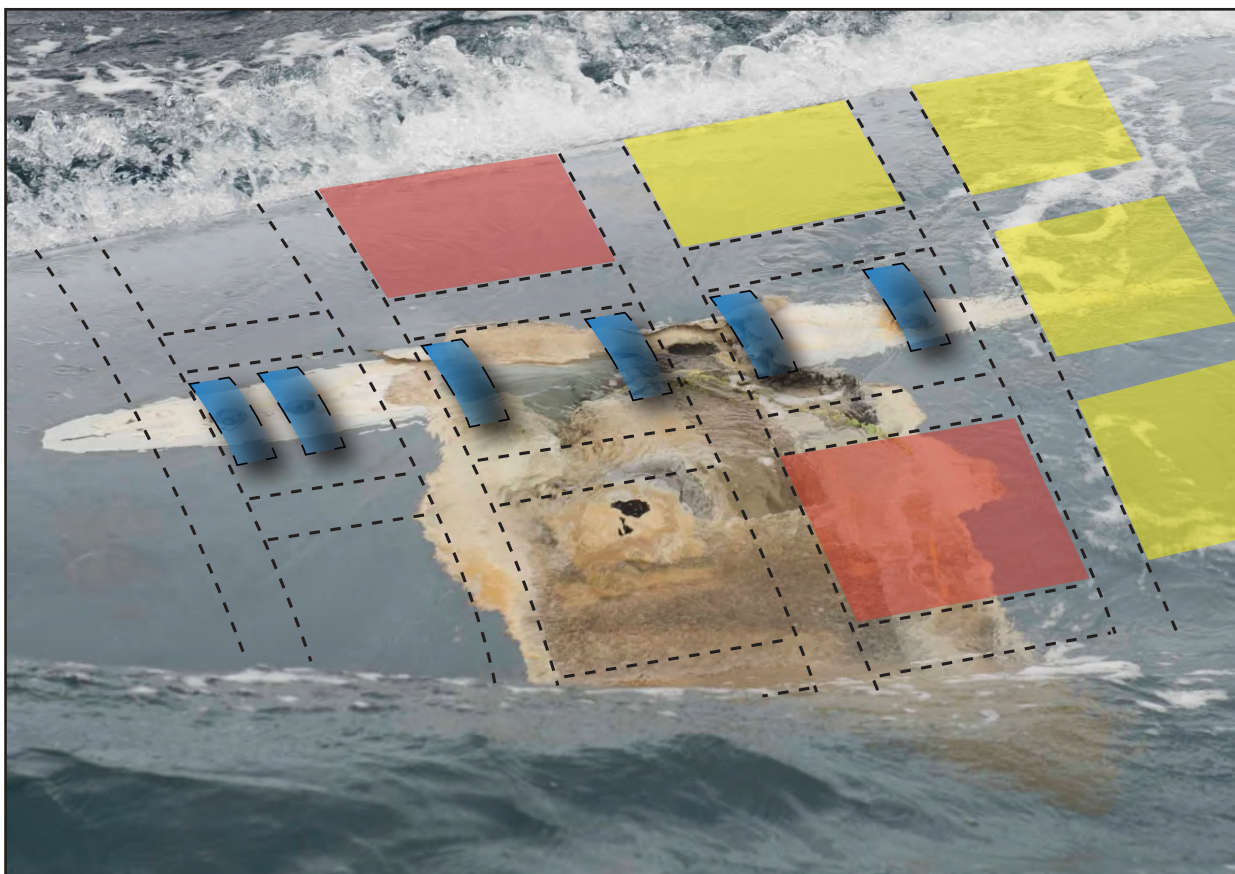
*'Remove floor boards and pipe work in way of damaged areas. Cut flanges off six bays, grind back hull, laminate and sides of structural floors. Bond structural floor to hull with GRP, lightly rub down and apply wax gel. Drill off limber holes, refit pipes and floors. Clean vessel. Lift plate washers and re bed'.*

*Cheeki Rafiki's* keel was not removed to carry out these repairs.

**Figure 19:** Figure 18 superimposed with the approximate position of the matrix frames and location of the bays probably (red) and possibly (yellow) repaired in 2007
