Report on the investigation of  
the loss of the yacht  
***Cheeki Rafiki***  
and its four crew  
in the Atlantic Ocean,  
approximately 720 miles east-south-east of  
Nova Scotia, Canada  
on 16 May 2014

## SYNOPSIS

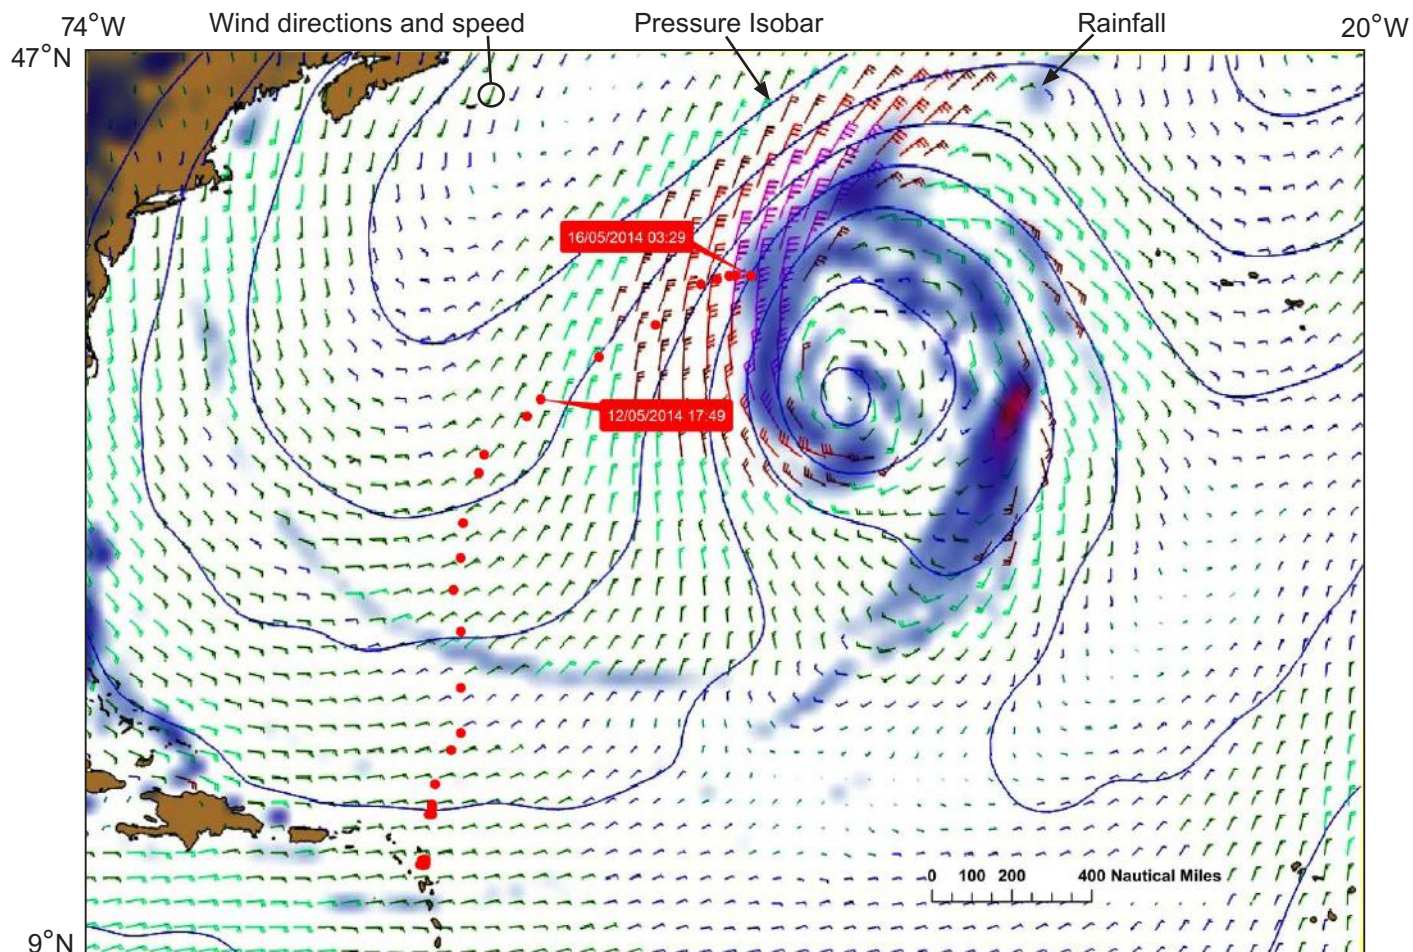
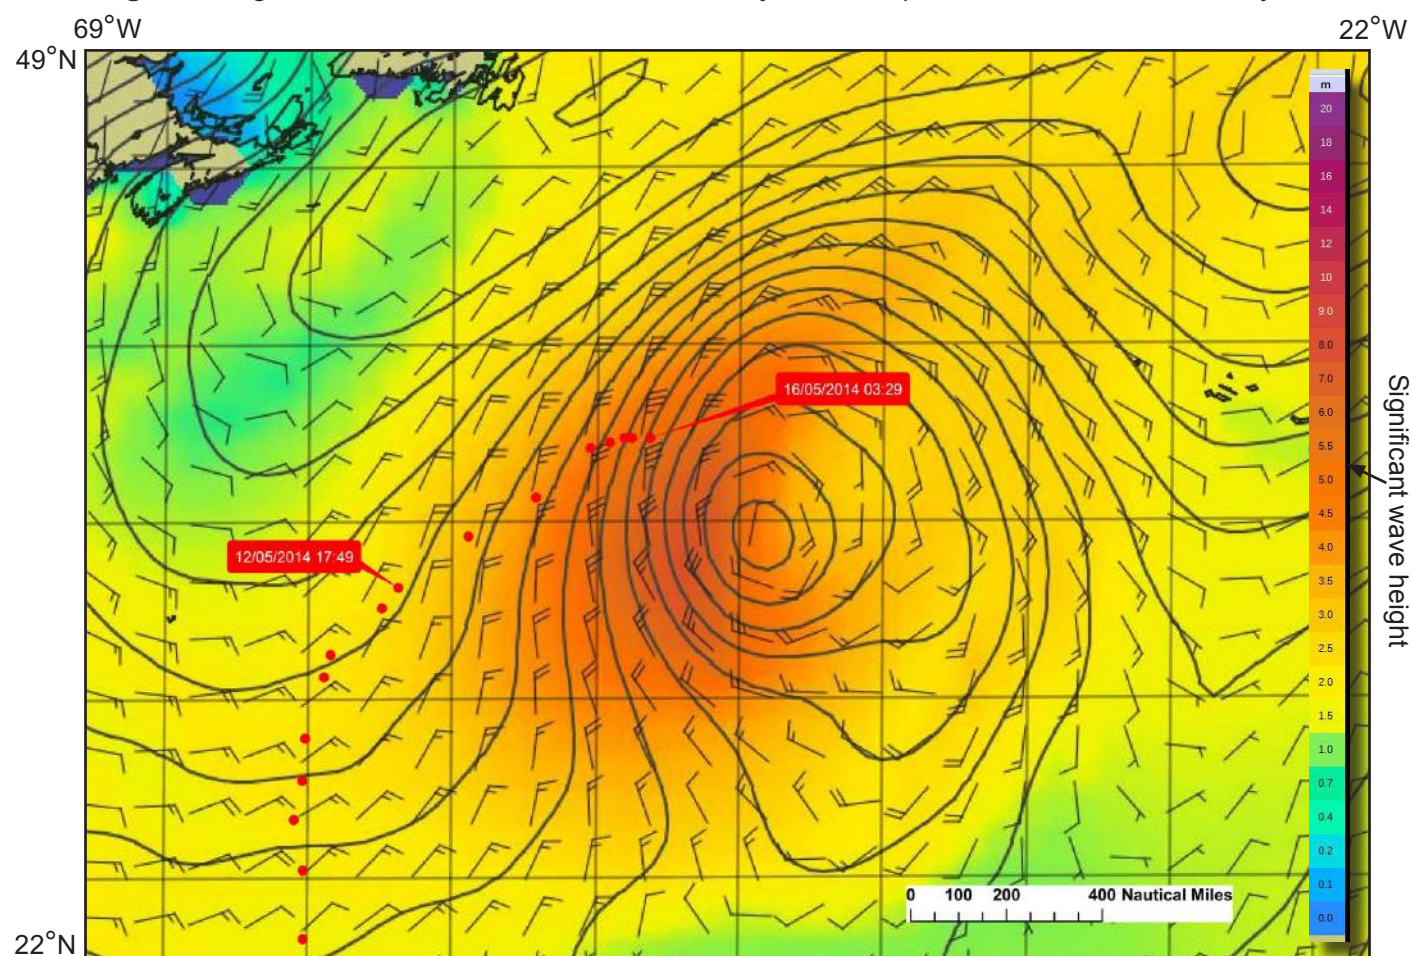
**Figure 4:** Ugrib forecast conditions for 0300 16 May 2014, as predicted at 0600 on 12 May 2014

In his email of Saturday 10 May the skipper reported having to use the engine the previous night due to light winds, and when the principal/director replied to that email on Monday 12 May he advised the skipper to '*perhaps steer NE*'. The principal/director's email mentioned that there would be lightish winds until Wednesday, but did not warn of the worsening conditions thereafter (see **Figures 4** and **5**) that were predicted in the Ugrib 12 May 0600 forecast.

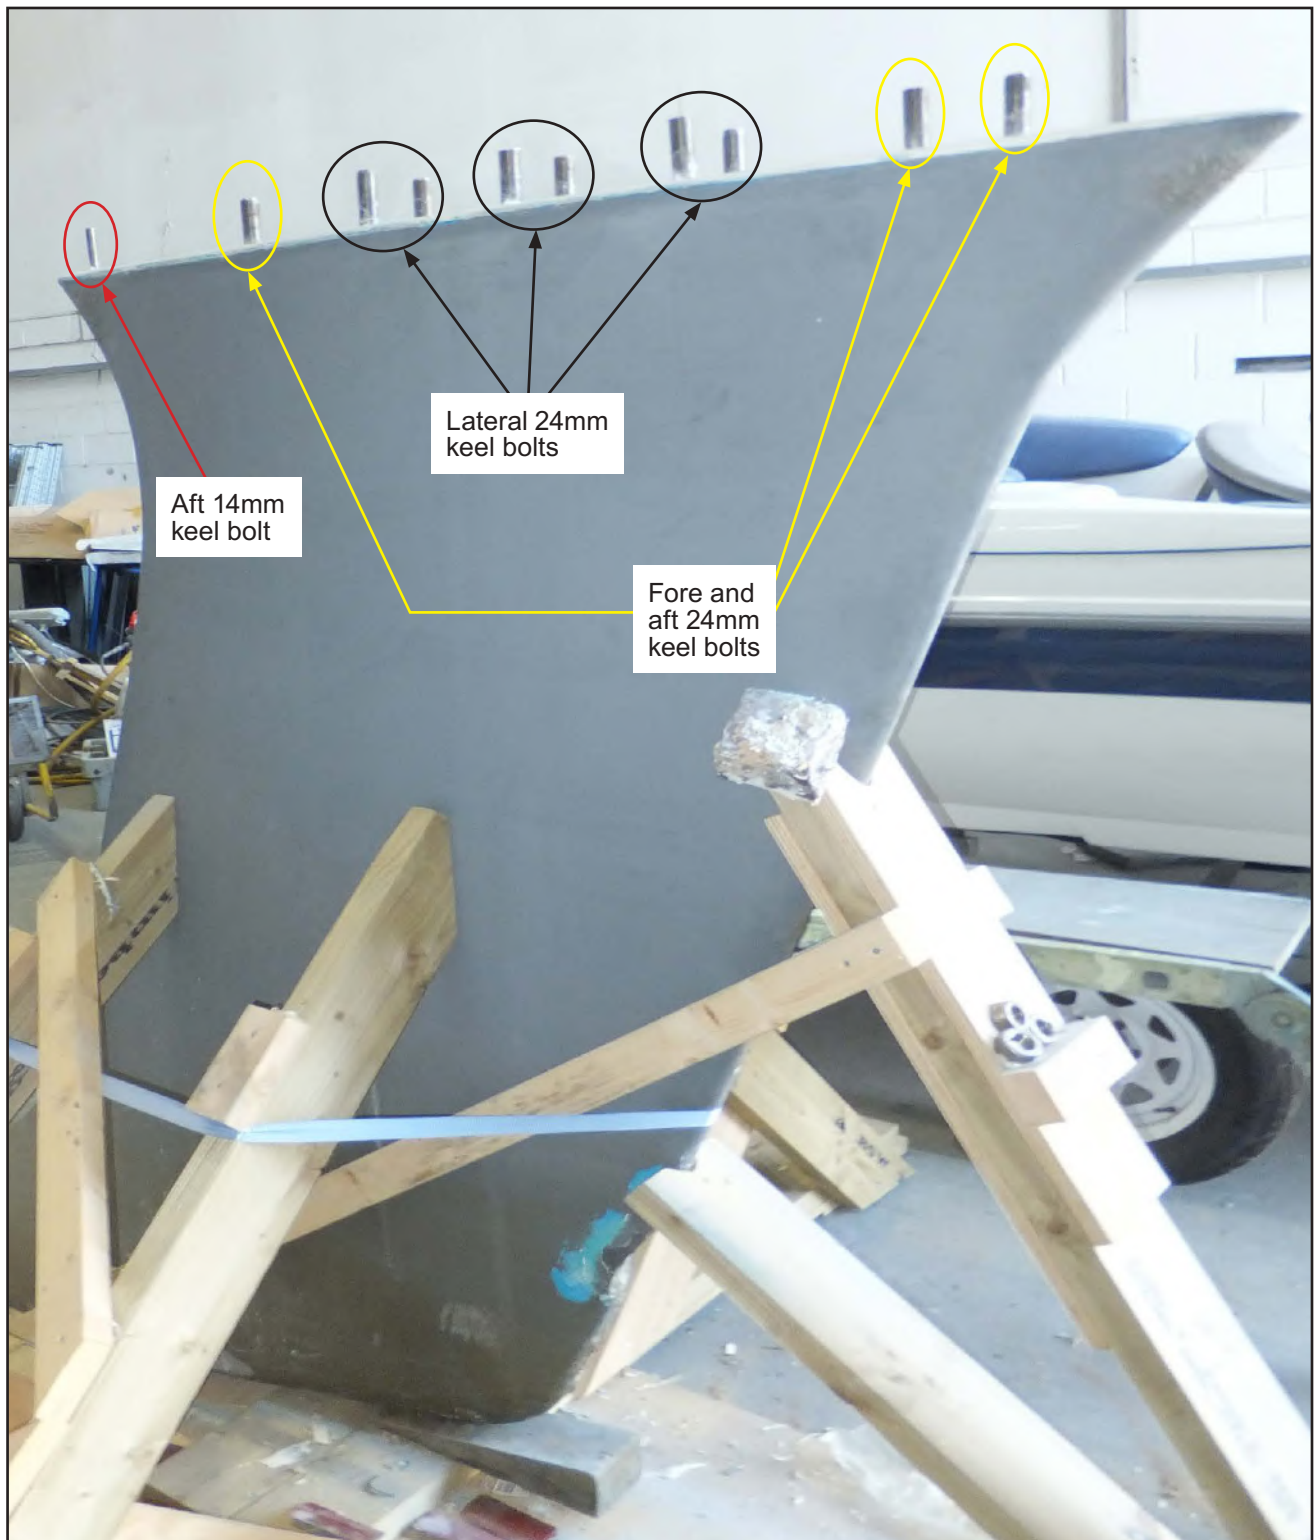
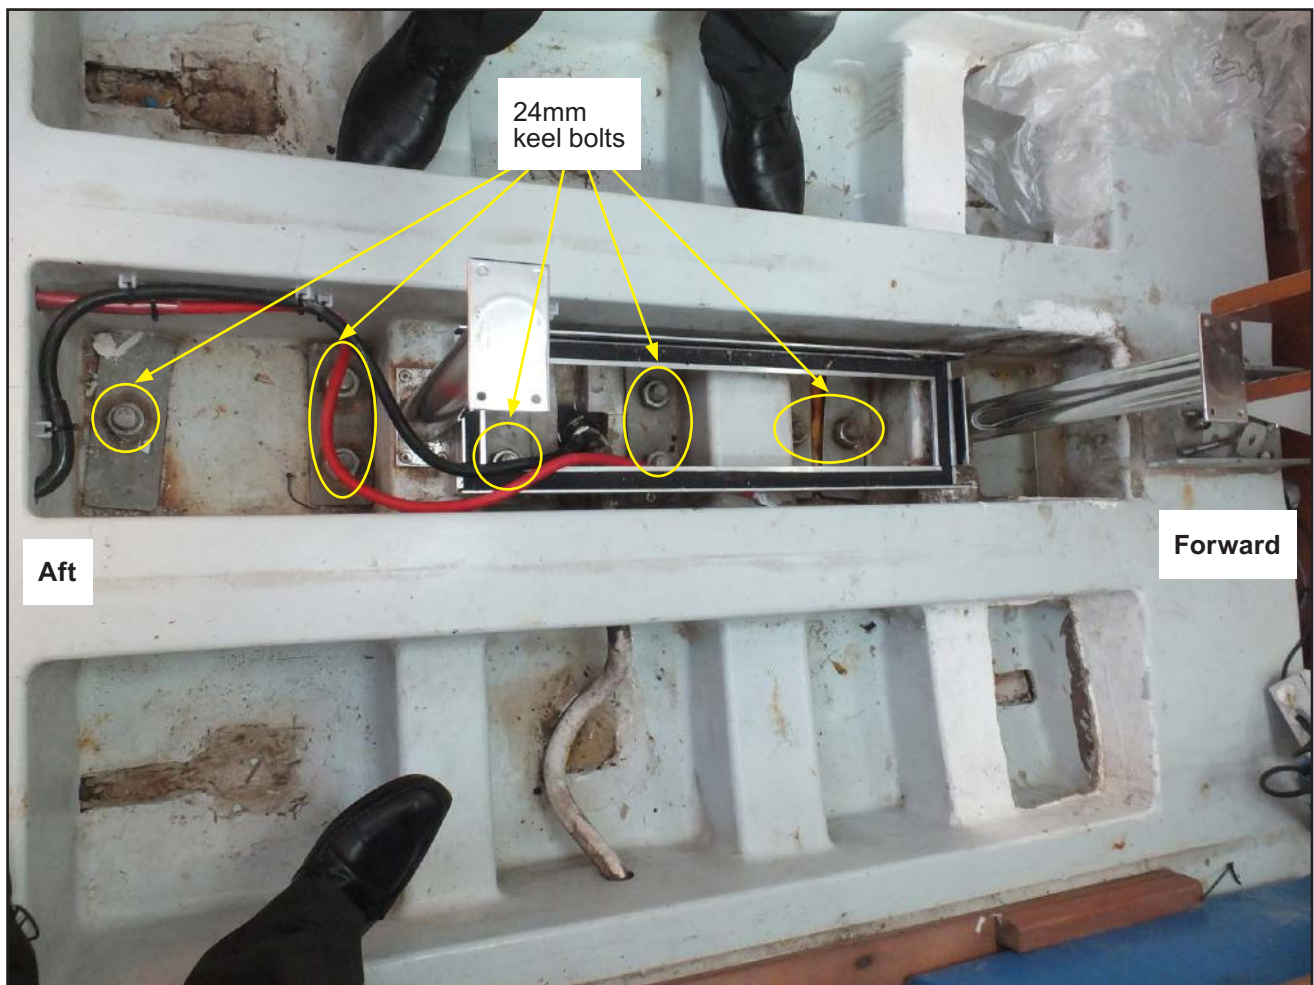
**Figure 9:** Typical Beneteau First 40.7 keel bolt arrangement (not *Cheeki Rafiki*)

The Beneteau First 40.7 was available with two keel options: a shorter cast iron bulb type keel and a more popular deep fin cast lead keel. The lead keel was manufactured with stainless steel bolts cast into it. There were nine 24mm bolts: three designed to carry the fore and aft loading on the keel, and six primarily to carry the lateral loading (**Figure 9**). The three bolts carrying the fore and aft loading were arranged with two single bolts at the forward end of the keel and one single bolt aft. The six bolts designed to carry the lateral loading were arranged in pairs. All of the 24mm bolts were secured to the glass reinforced plastic (GRP) hull with a washer (i.e. backing) plate and nut (**Figure 10**).

In addition, the design provided for a 14mm bolt at the extreme forward end and at the after end of the keel, to prevent the GRP flexing away from the top of the keel. However, only the aft bolt was installed in the manufactured product owing to insufficient material being available in which to effectively install the forward bolt (**Figure 9**). The Wolfson Unit's assessment of the keel structure (**Annex C**) was based on a Beneteau First 40.7 design incorporating only the aft 14mm bolt.

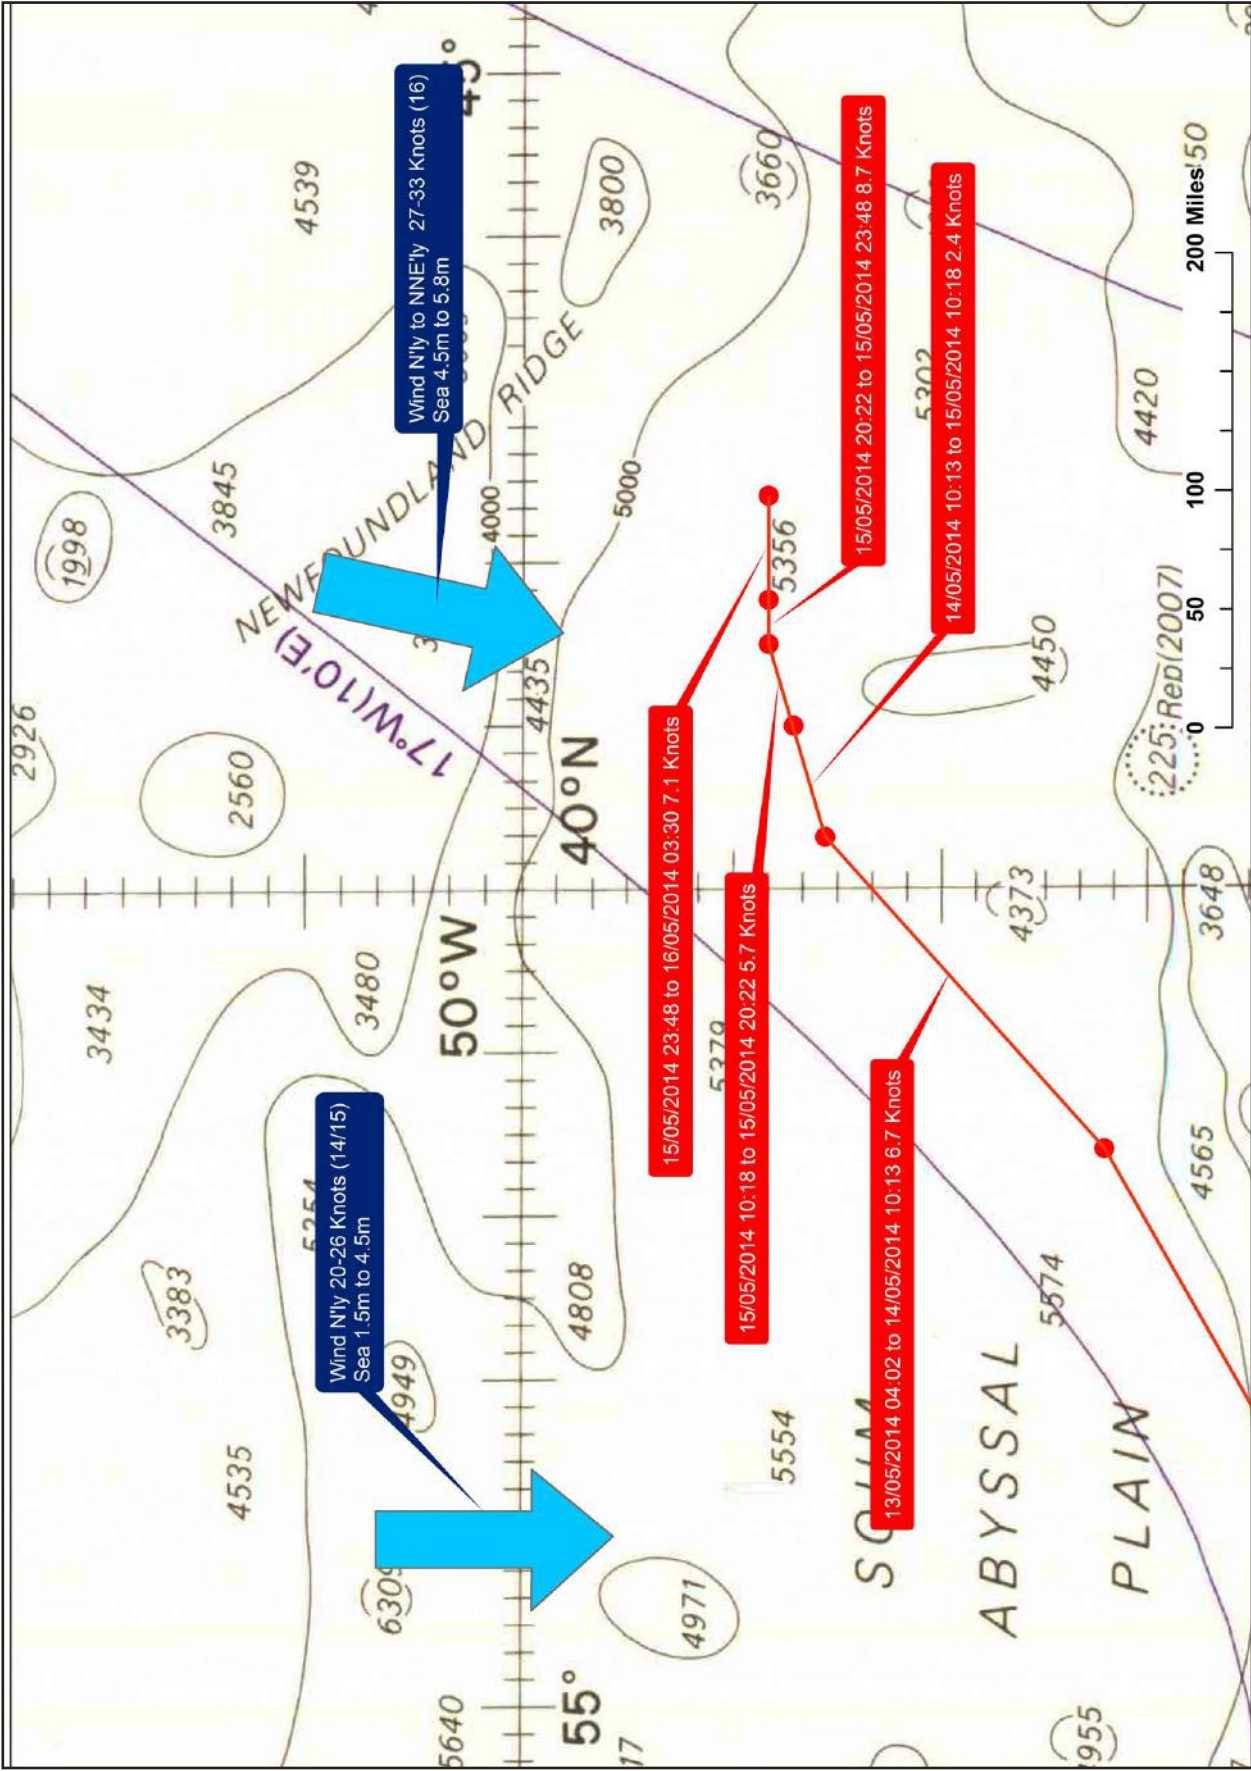
**Figure 20:** Cheeki Rafiki's indicative courses and speeds made good obtained from its Iridium satellite telephone recorded positional data between 14 May and 16 May 2014

Without the benefit of the principal/director's advice, it is possible that the skipper had neither identified nor considered that the source of water ingress was in the keel area. Consequently, it is probable that he had neither recognised the increasing risk of the keel becoming detached nor the danger of continuing on the same approximate course without reducing speed (**Figure 20**), producing high lateral keel load; a point not included in the principal/director's advice.
